CONDITION SURVEY AND RESERVE STUDY

DERBY LOFTS CONDOMINIUM SALEM, MASSACHUSETTS

| SUBMITTED TO: | Derby Lofts Condominium Condominium Trust c/o Great North Property Management 182 Newbury Street Peabody, Massachusetts 01960 |
|---|--|
| DATE: | April, 2008 |

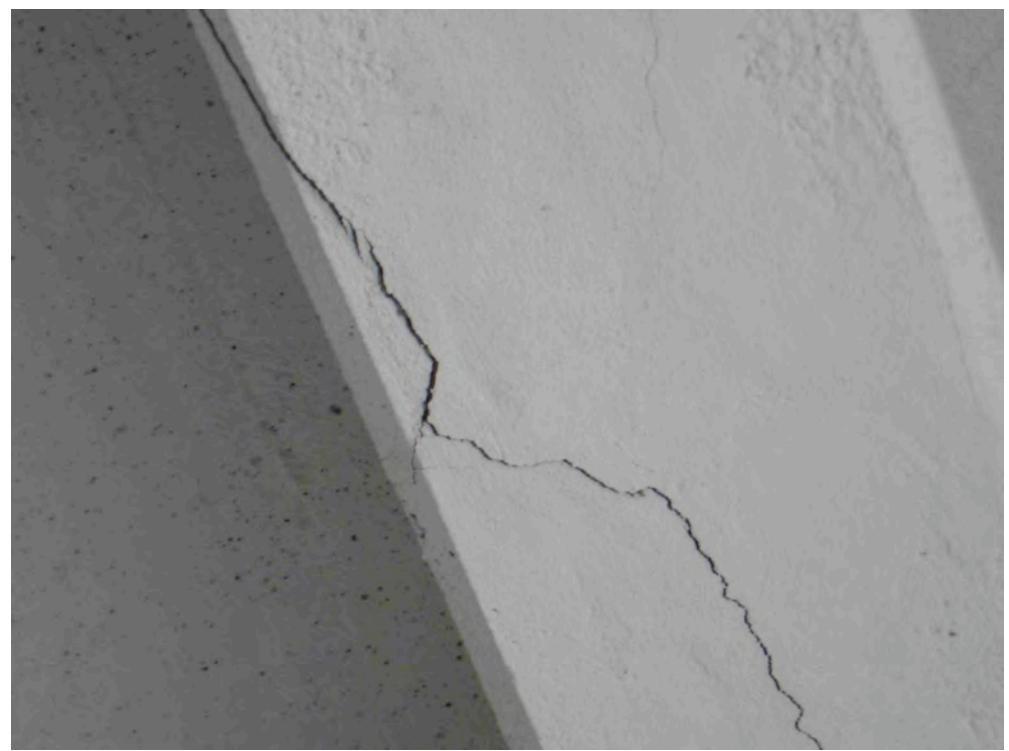
Inspection of the exposed beams and columns throughout the building showed varying degrees of cracking in the concrete casings. Some of the most severe cracking was noted in two beams in the bedroom of Unit #309. These cracks have opened to approximately 1/8" in width, and in one location a section of concrete appears to have spalled on two sides and may be loose (see Photograph #2). Many of these beams were original to the building, and probably consist of reinforced concrete with internal steel rebar reinforcement. Corrosion and subsequent expansion of the internal steel reinforcement is a likely source of the cracking of these beams.

Photograph #2 – Cracking Of Concrete Beam In Unit 309

To address potential safety hazards posed by loose concrete such as that noted in the two beams in the bedroom of Unit #309, loose concrete materials should be removed. After these materials are removed, the underlying structure should be examined to better determine the cause of the cracking. Appropriate repair procedures can then be determined. This work should be considered a #1 Priority. This work should be performed on a time and materials basis.

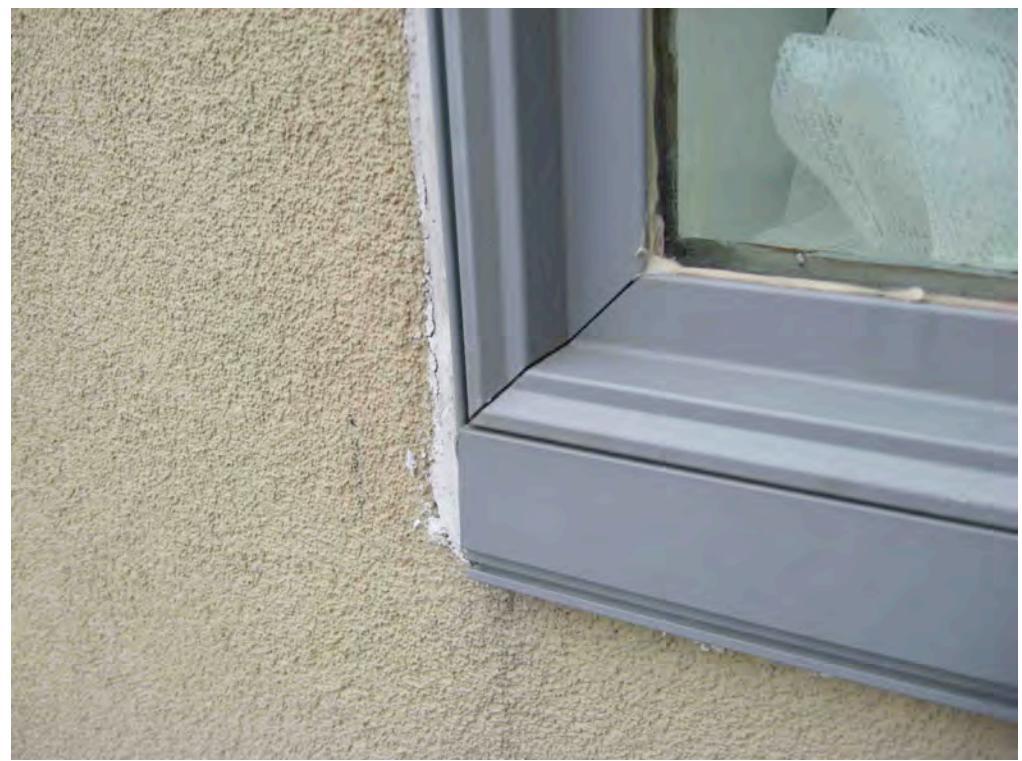
Water infiltration may be occurring from a number of sources around these window openings. These include, water infiltration directly through the sashes, water penetrating the window frames and water penetrating improperly sealed joints around the window perimeters. Water staining was noted on the interior window frame surfaces in several Units (see Photograph #4). The joints and openings in the frames of this type of window can be a significant source of water infiltration. These frames are constructed of multiple members. Openings and some degree of water infiltration should be anticipated in virtually any window frame after several years of service (see Photograph #3), even if the frame is generally sound and functioning properly.

Photograph #3 – Corner Joint In Fixed Window Frame

Window replacement should include complete removal of the existing units to the structural rough openings to allow the new units to be installed with sill flashings below the frames. These flashings should be turned up behind the backs and ends of the sills and drained to the building exterior. These flashings should prevent any water infiltrating joints or other openings in the frames from reaching the underlying wall areas and entering the building. This work should be considered a #1 Priority. The final cost of this work will depend on the final selection of windows and other details. However, we would recommend a preliminary budget allowance of \$800,000.00 to \$1,200,000.00 for this work.

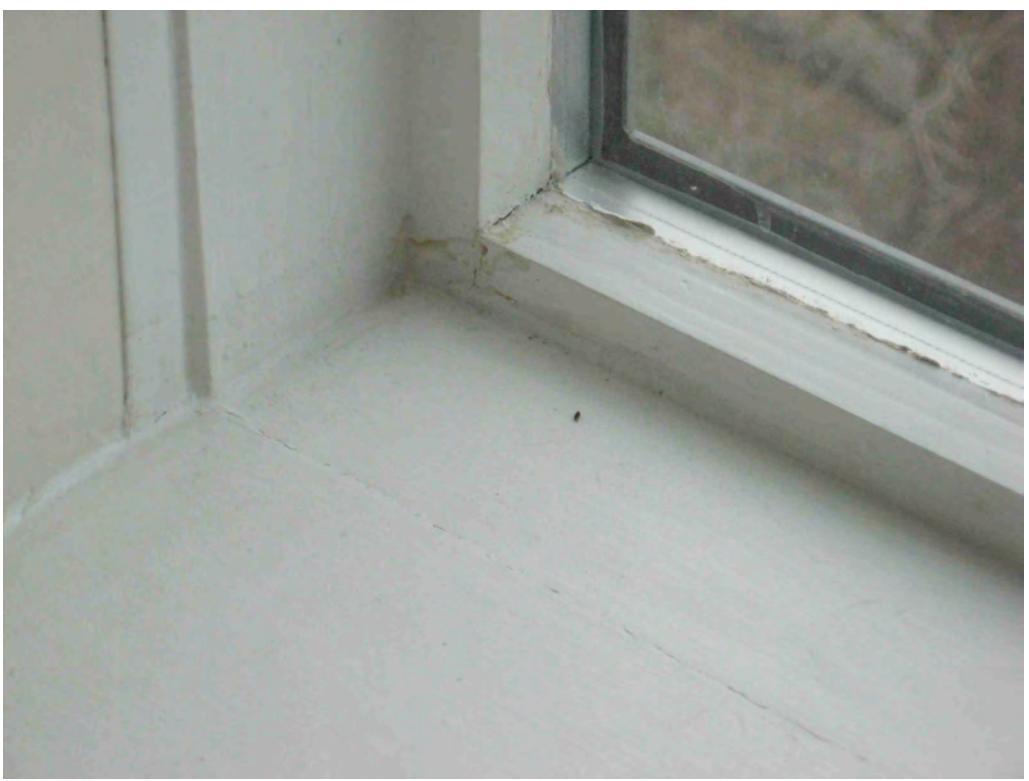
Owner surveys indicate water infiltration through the windows and water damage to the interior gypsum finish around the windows is a problem in up to 22 of the 54 Units in the building. In addition, air infiltration and operational difficulties were also commonly reported. Several Owners also reported excessive deflection in the large fixed window glass. The existing double-hung sashes have been provided with what appear to be retrofitted braces, which may have been necessary due to the relatively large size of the sashes for the window's operating hardware (see Photograph #6). In addition, some operable sashes have reportedly been fixed in place due to water/air infiltration and operational issues.

Photograph #4 – Water Staining On Interior Face Of Fixed Window

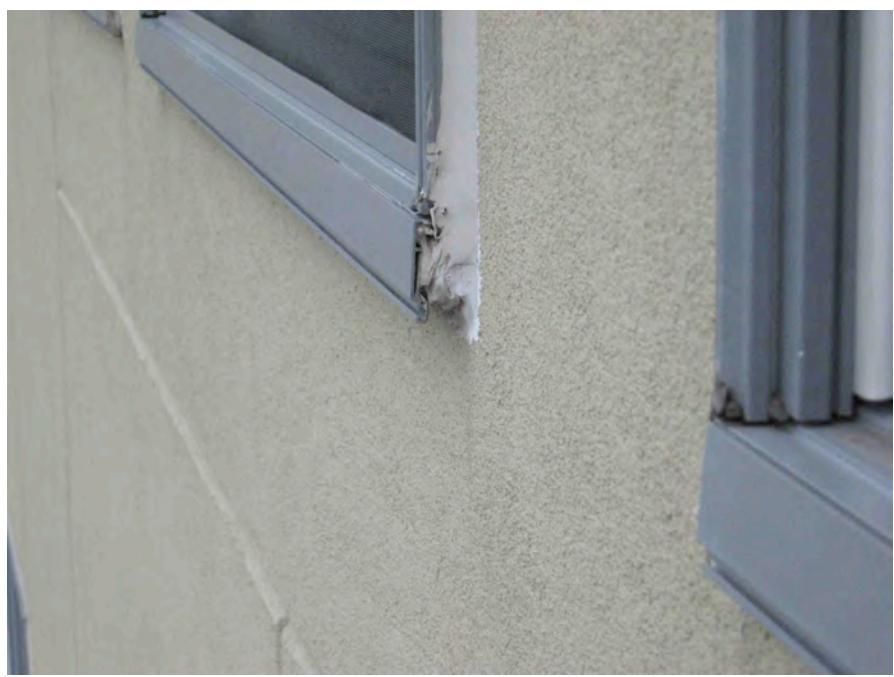
In addition, what appear to be sealant repairs were noted on various joints in window frames and mullion covers between window units.

Photograph #5 – Sealant Applied To Exposed End Of Window Frame

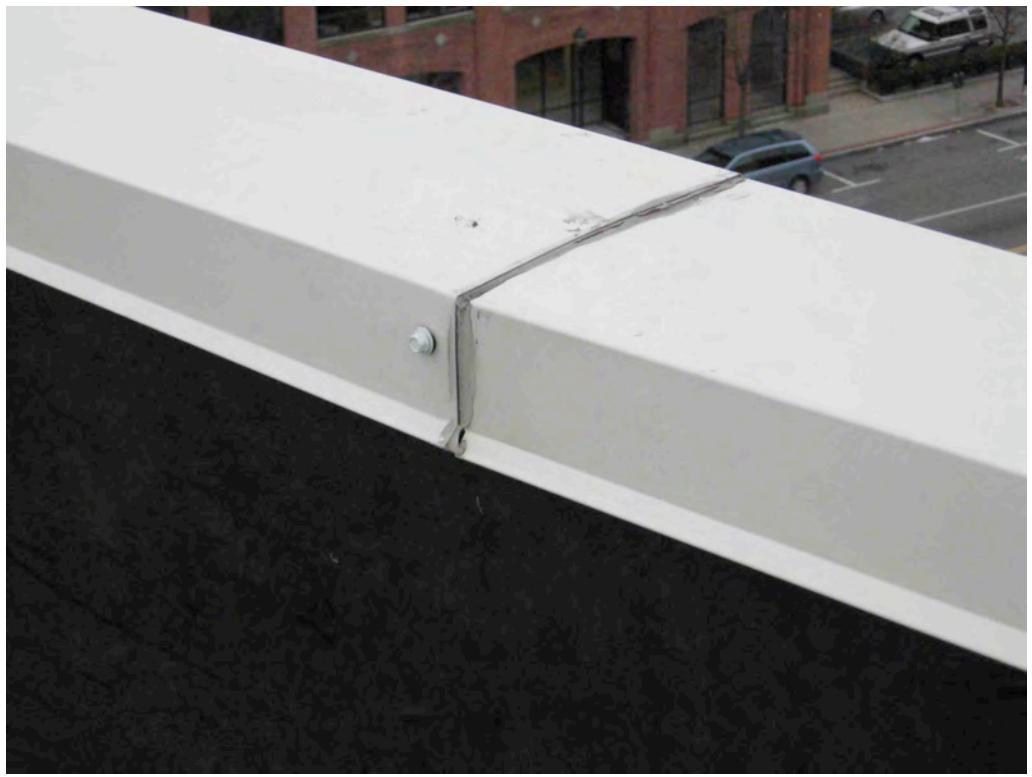
The field membrane has been extended up the interior surface of the parapet wall to the level of the aluminum coping (see Photograph #21). Inspection of corner sections indicated that the field membrane was not extended over the top of the parapet. Aluminum copings in place on the top surface of the parapet walls appeared to be in generally good condition at the time of inspection, although sealant materials between coping sections have begun to fail in some areas (see Photograph #10).

Photograph #10 – Sealant Materials On Rooftop Parapet Cap

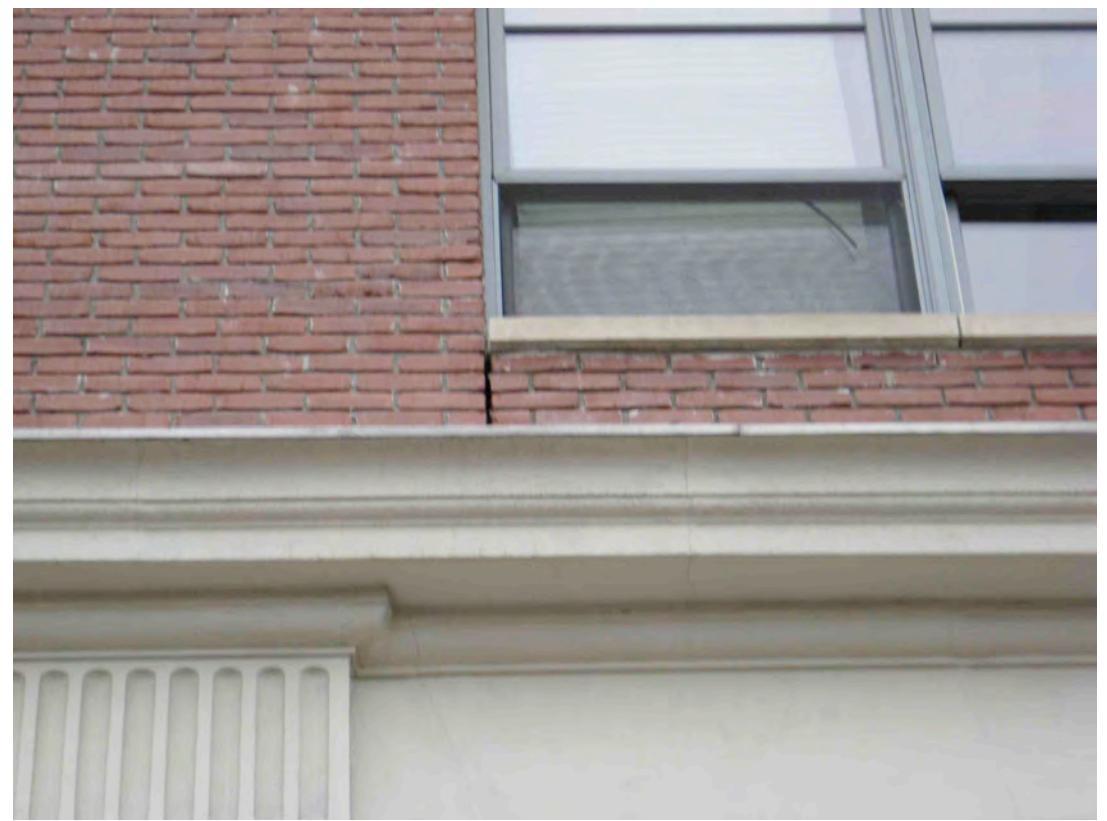
The masonry walls are broken by vertical control joints in various locations. These control joints consist of a continuous break in the masonry veneer which is sealed with a soft sealant material. These joints are installed in masonry walls to allow settlement or movement due to variations in temperature and moisture in the masonry. The movement in the masonry materials is concentrated at the soft control joint, thereby relieving stresses and preventing damage to the masonry materials. These joints are typically provided in long wall sections which will experience significant overall expansion and contraction, at locations where the thickness or height of the wall changes, at control joints in the underlying structural frame of the building, and other locations where stresses will be concentrated in the masonry. One section of control joint at a window corner was noted to be missing sealant materials on the Derby Street elevation (see Photograph #12).

Photograph #12 – Unsealed Joint In Masonry Veneer On Derby Street Elevation

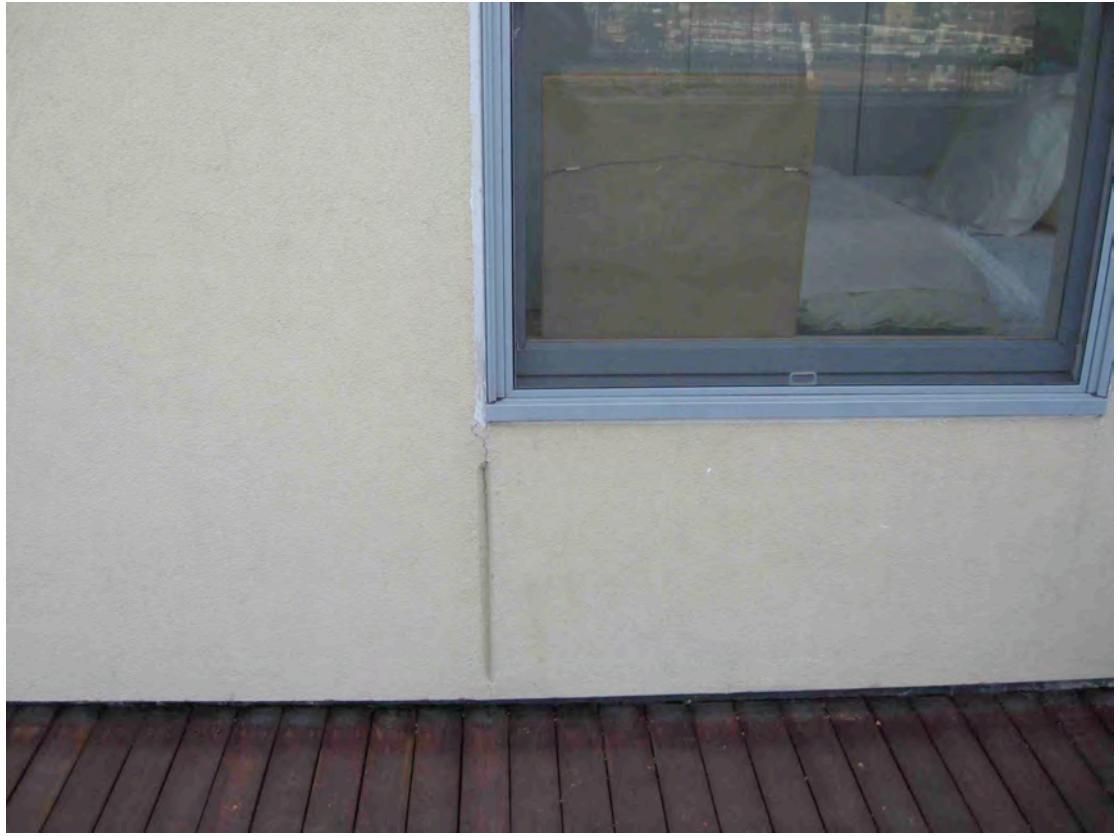
Inspection of the existing EIFS surfaces revealed moderate damage to the EIFS, specifically on the Unit 610 balcony and at the base of the sixth floor windows in the rear lightwell. Significant cracking of the EIFS was also noted at the corners of many window openings where control joints were not continuous for the full height of the wall (see Photographs #13 & #14). In addition to cracks and other deficiencies in the existing EIFS surfaces, several potential sources of water infiltration into the EIFS wall systems were noted, including the following:

Photograph #13 – Cracked EIFS Wall Surface At Window Corner

This work should be considered a #1 Priority. We would recommend a preliminary budget allowance of \$100,000.00 to \$150,000.00 for this work.

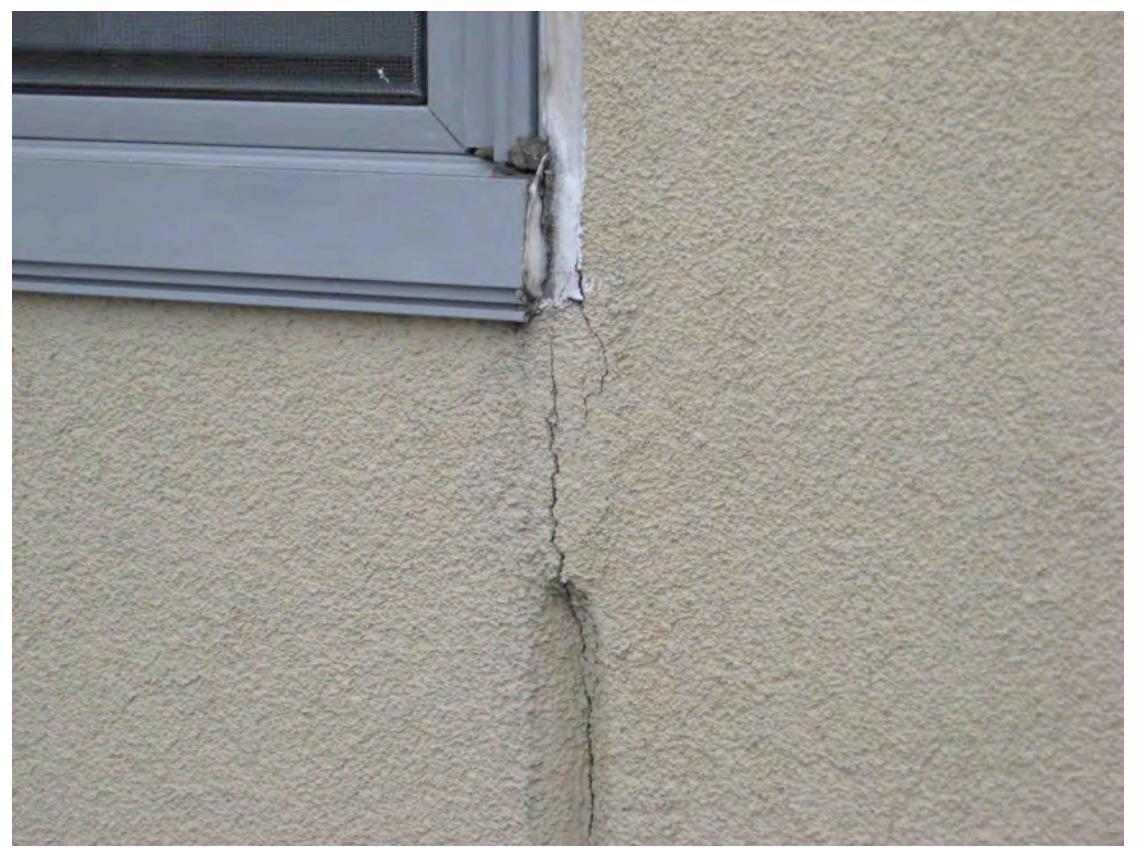
Photograph #14 – Cracked EIFS Wall Surface At Window Corner

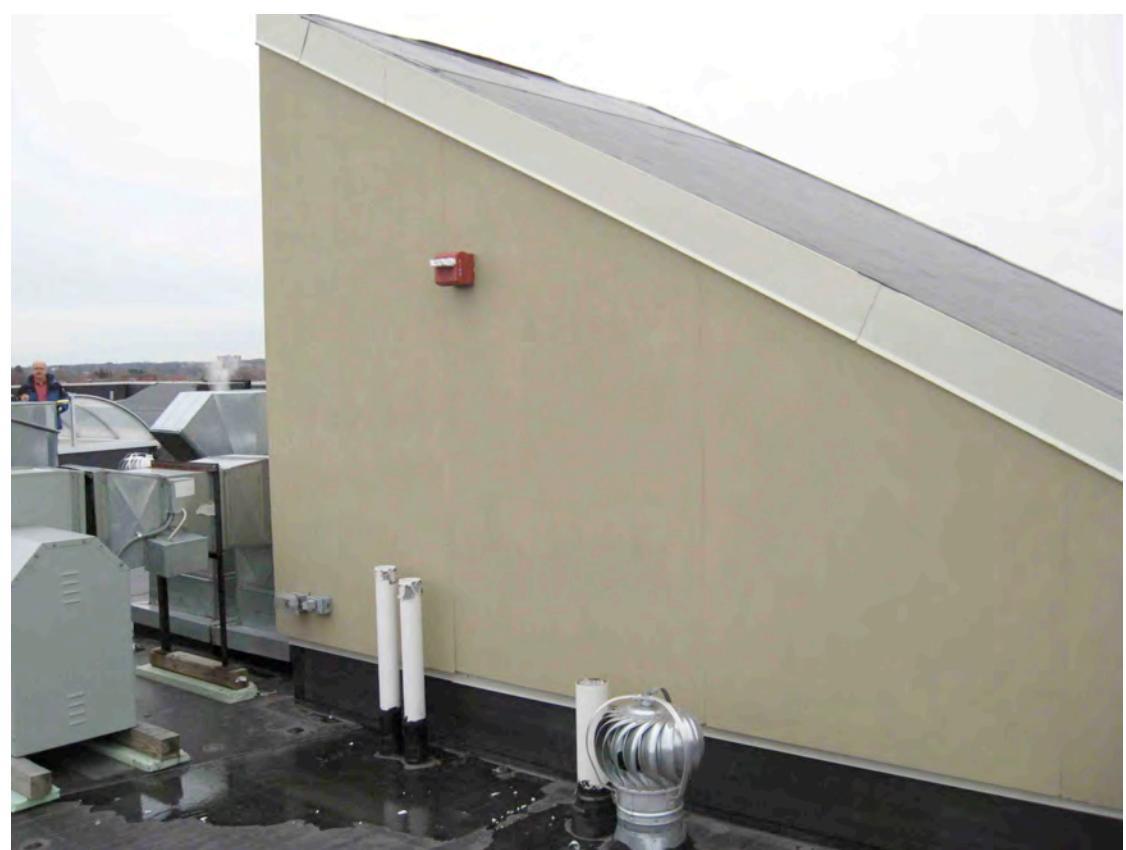
Exterior wall areas on the main roof penthouses and interior faces of lower balcony parapets are covered with fiber-cement panels (see Photograph #15). It should be noted that these are relatively new products in the New England area, and basically unproven. Therefore, we would consider the long-term durability of these materials to be a significant concern. It is our experience that these products may be prone to deterioration in this environment.

Photograph #15 – Fiber-Cement Siding On Rooftop Penthouse

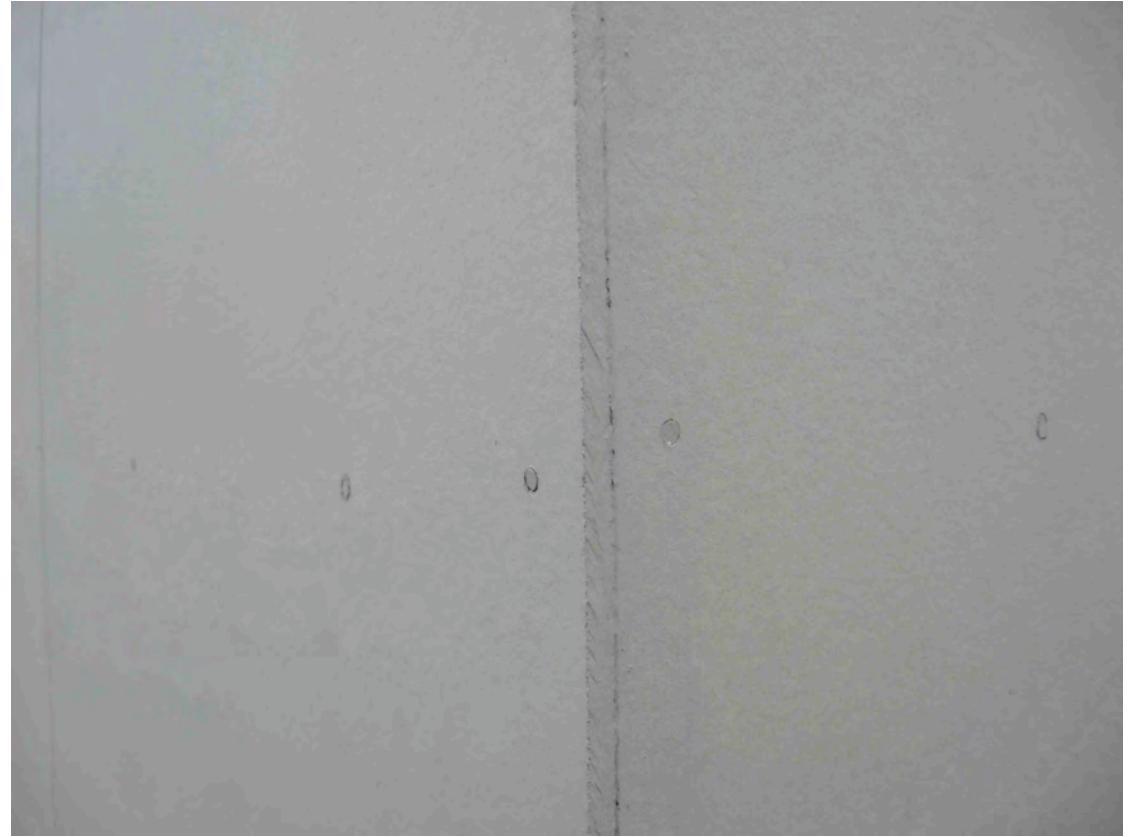
Inspection of the exposed fiber-cement panels showed open panel joints and unsealed fastener heads in areas, particularly on the rooftop penthouses (see Photograph #16). Review of photographs from the conversion construction shows the back-up materials on these walls to consist of asphaltic waterproofing membrane and plywood sheathing. If these waterproofing materials are properly installed, water infiltration through the siding materials should not be a significant problem. However, water infiltration through open joints and fastener holes may accelerate deterioration of the fiber-cement panels themselves.

Photograph #16 – Unsealed Fastener Heads In Fiber-Cement Siding

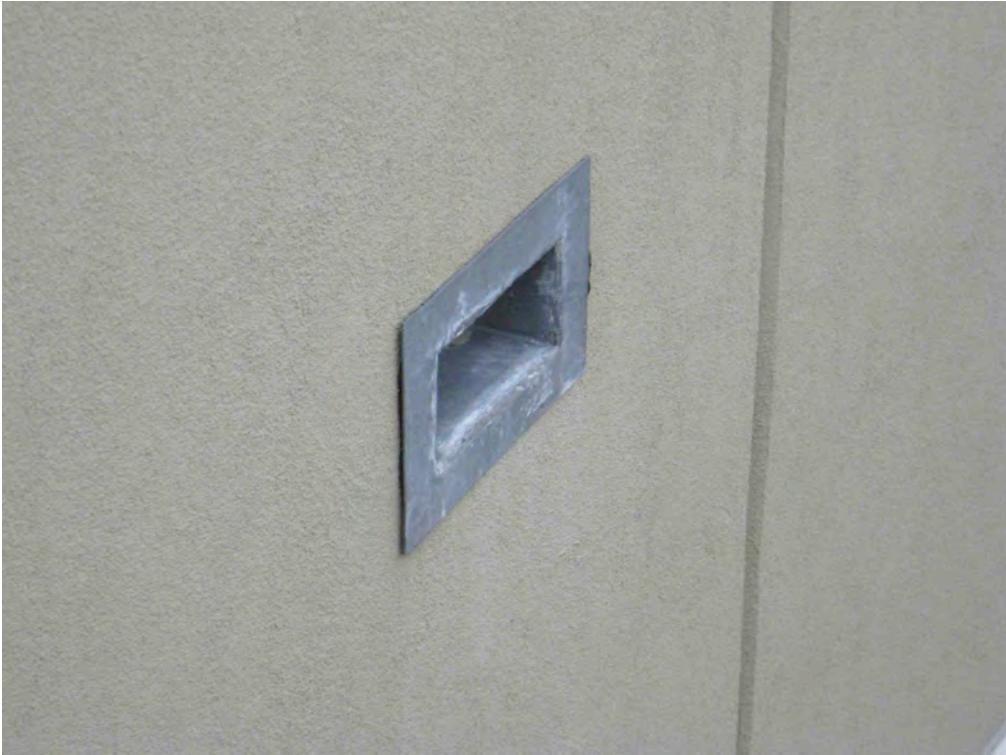
- Failed sealant materials on joints between window/door frames and EIFS materials.
- Failed sealant materials on joints between metal clad bands and EIFS materials.
- Unsealed joints between roof/balcony scupper flashings projecting through EIFS wall sections (see Photograph #17).

Photograph #17 – Metal Scupper Flashing With Unsealed Joints

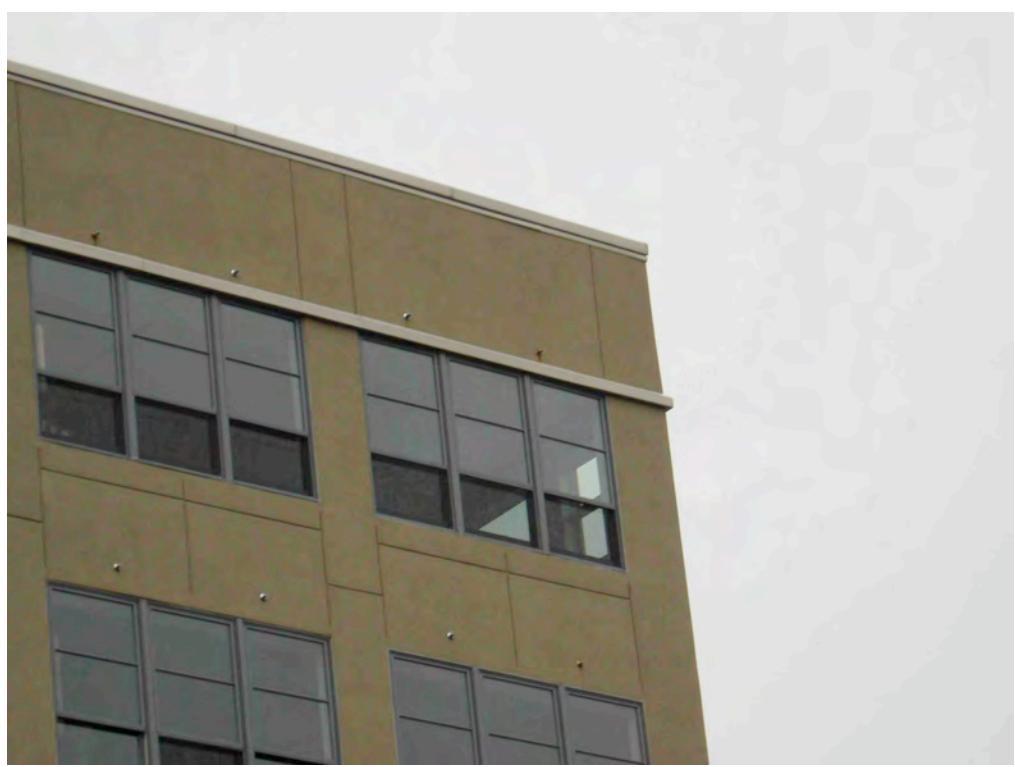
Photograph #18 – Sprinkler Heads With Unsealed Joints

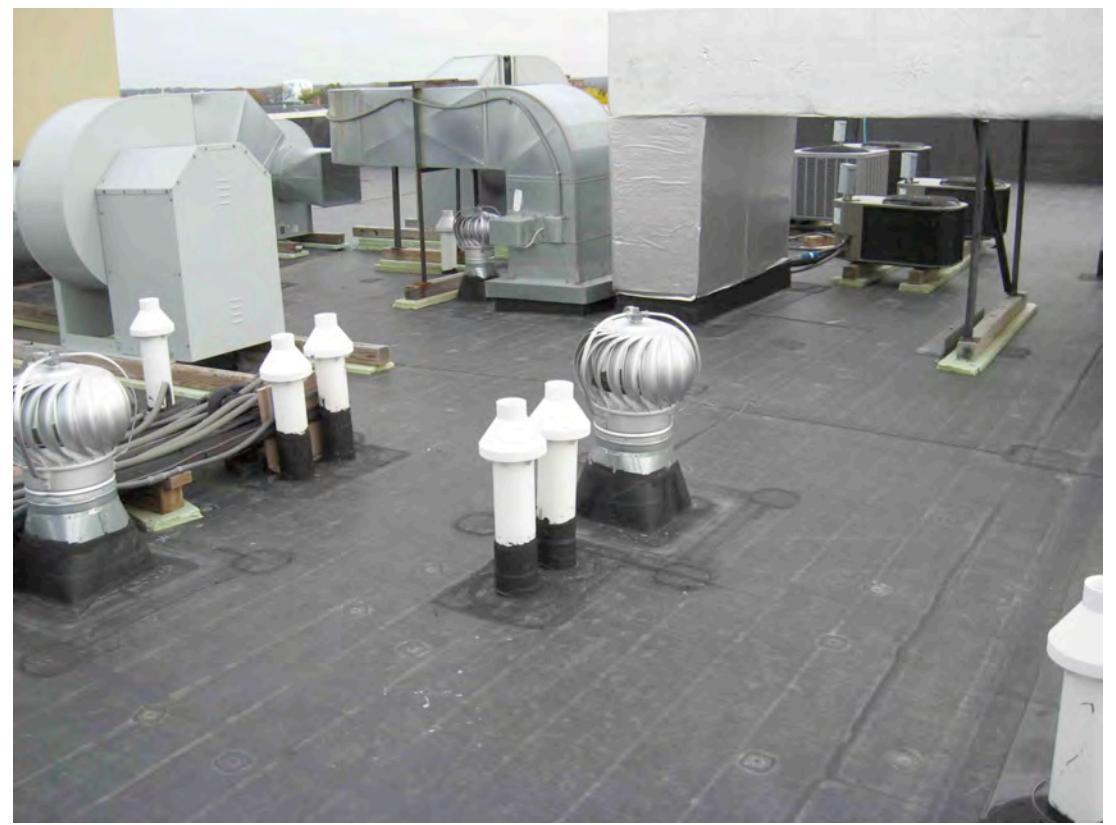
The main roof on this building consists of a fully adhered EPDM single ply membrane system manufactured by Carlisle Syntec Systems (see Photograph #20). EPDM roof systems consist of individual sheets of single ply membrane bonded together with adhered seams to form a continuous roof system. The membrane in a fully adhered system is adhered to rigid insulation which is fastened with screws and stress plates to the structural roof deck. Waterproofing systems on lower level balconies also consist of EPDM membrane systems. These appear to be loose laid under wooden deck platforms which hold them in place.

Photograph #20 – EPDM Membrane Roof With Various Flashing Details

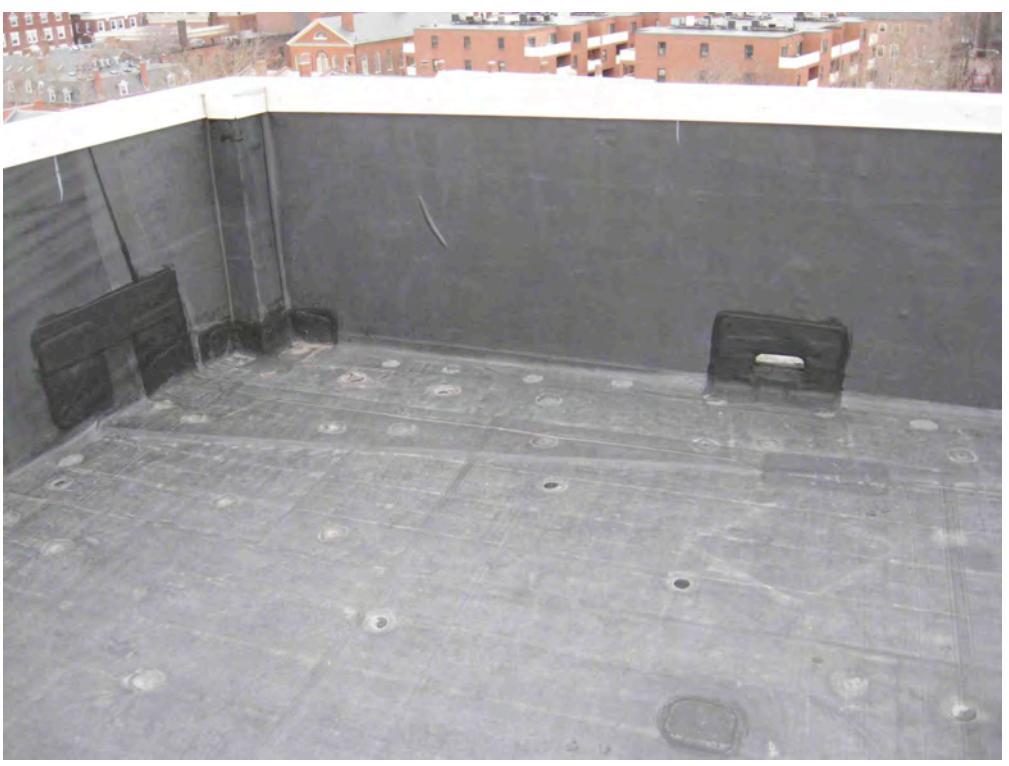
Photograph #21 – EPDM Membrane Run Up Parapet Wall

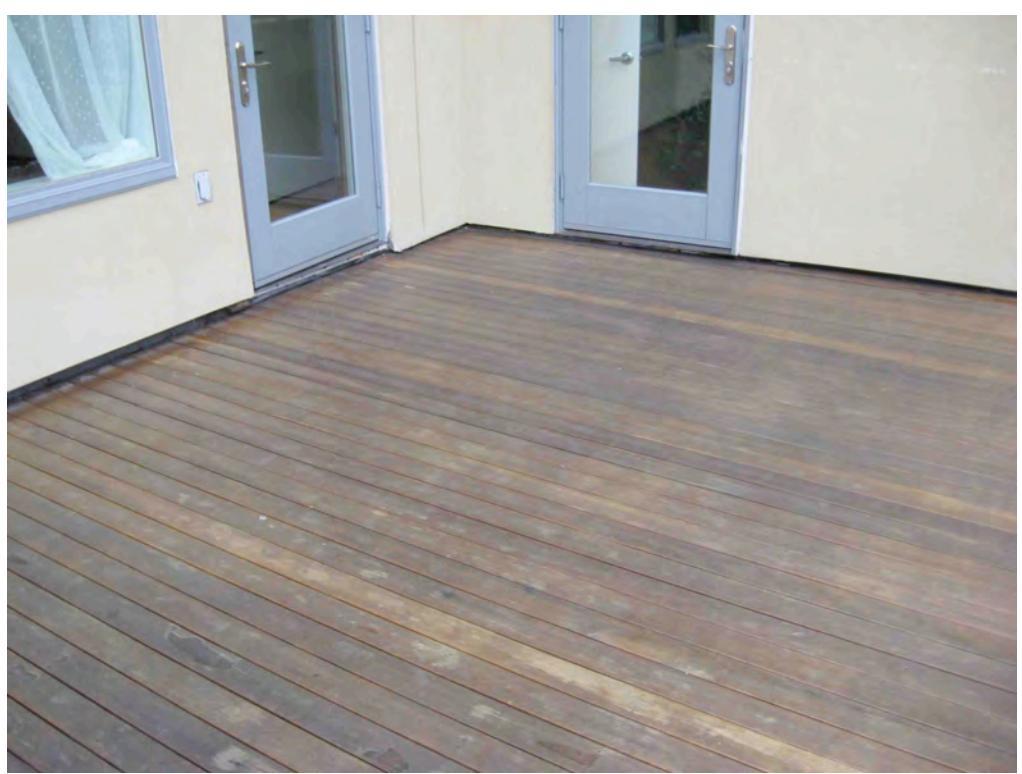
The rooftop deck platform appears to be in generally satisfactory condition. The deck boards are fairly faded and show moderate cracking and checking. Both the fading and checking are typical for wood materials with direct exposure to the sun. Deck platforms on lower balconies show less fading and checking (see Photograph

#22). This is presumably due to individual Owners treating the exposed wood surfaces with waterproofing or water repellent stain. It should be noted that various wood stains and water repellents contain solvents which are incompatible with EPDM membrane and/or membrane seams, and may cause significant damage to these membrane systems.

Photograph #22 – Exterior Balcony On Upper Floor Unit

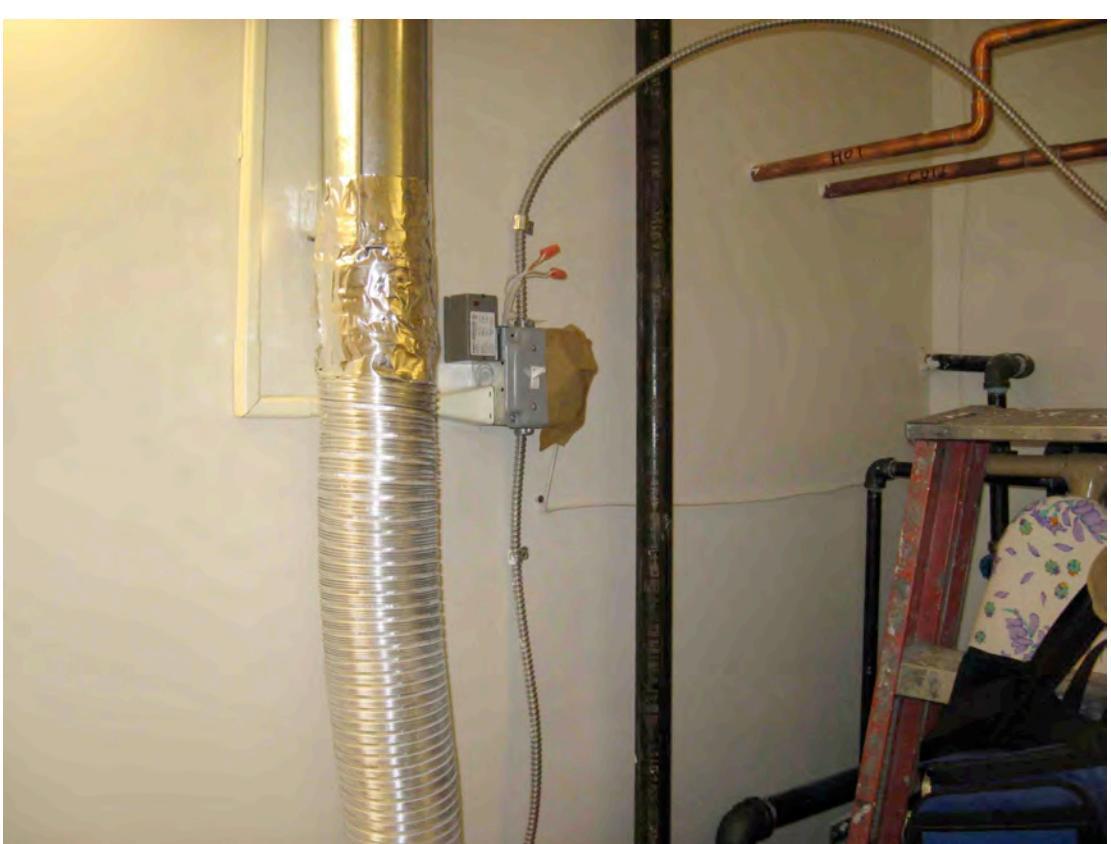
Electrical panels and meters for all Units are located in the main electrical room on the first floor. The electrical renovation of the building appears to have been generally properly designed and installed. However, inspection of some work subsequently completed in individual Units appears to be improper, and not in compliance with applicable Code requirements. This includes electrical work in the utility room of Unit 509, where a wall mounted light has been wired into the shut-off switch for the hot water heater, and capped wires have been left exposed outside of the wall mounted box (see Photograph #23).

Photograph #23 – Exposed Wiring In Utility Room Of Unit 509

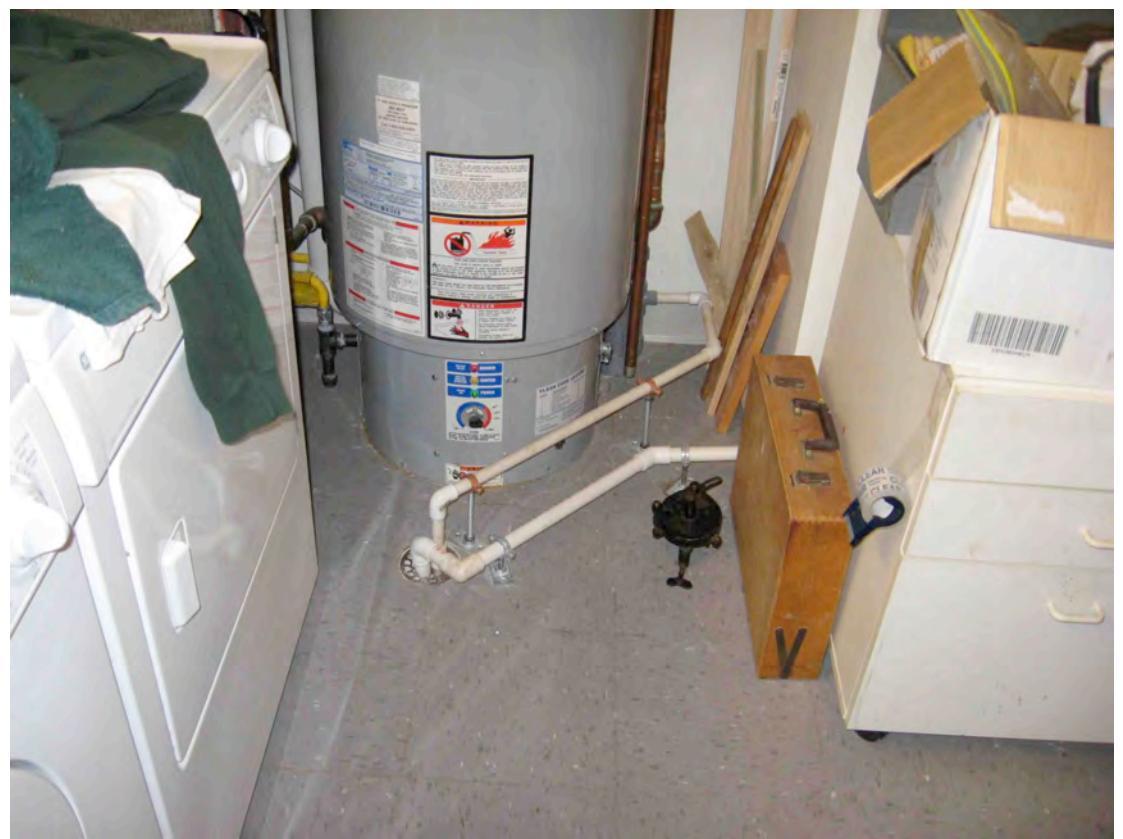
Photograph #24 – Water Heater Without Pan In Utility Room Of Unit 509
