CONDITION SURVEY AND RESERVE STUDY

DERBY LOFTS CONDOMINIUM SALEM, MASSACHUSETTS

| SUBMITTED TO: | Derby Lofts Condominium Condominium Trust c/o Great North Property Management 182 Newbury Street Peabody, Massachusetts 01960 |
|---|--|
| DATE: | April, 2008 |

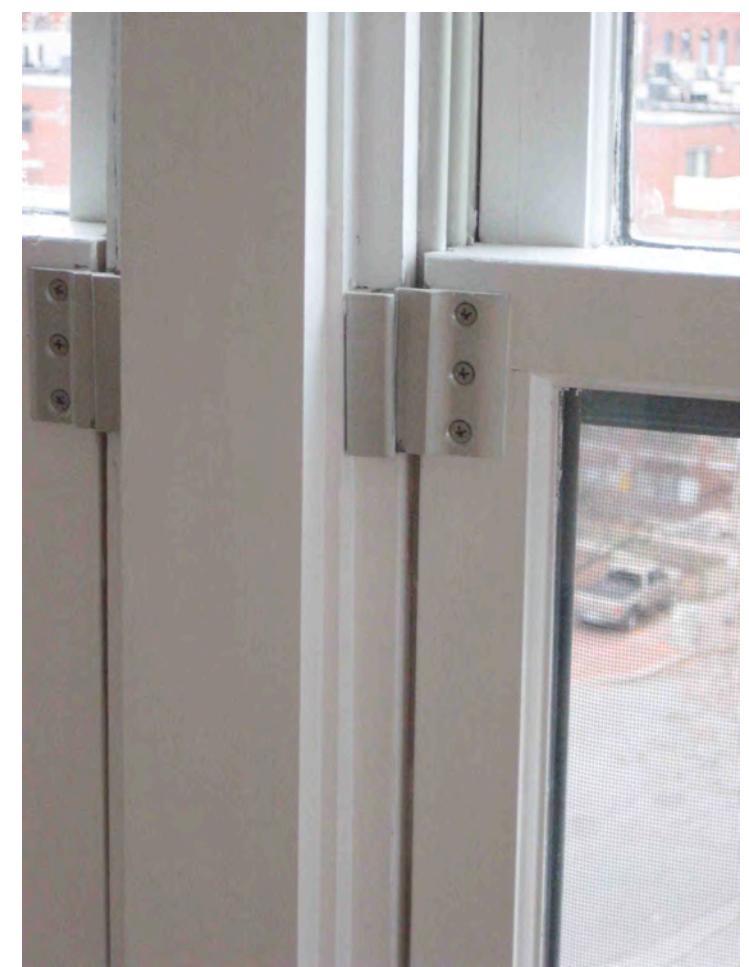
Owner surveys indicate water infiltration through the windows and water damage to the interior gypsum finish around the windows is a problem in up to 22 of the 54 Units in the building. In addition, air infiltration and operational difficulties were also commonly reported. Several Owners also reported excessive deflection in the large fixed window glass. The existing double-hung sashes have been provided with what appear to be retrofitted braces, which may have been necessary due to the relatively large size of the sashes for the window's operating hardware (see Photograph #6). In addition, some operable sashes have reportedly been fixed in place due to water/air infiltration and operational issues.

Photograph #6 – Brace Added To Operable Sash Of Double-Hung Window

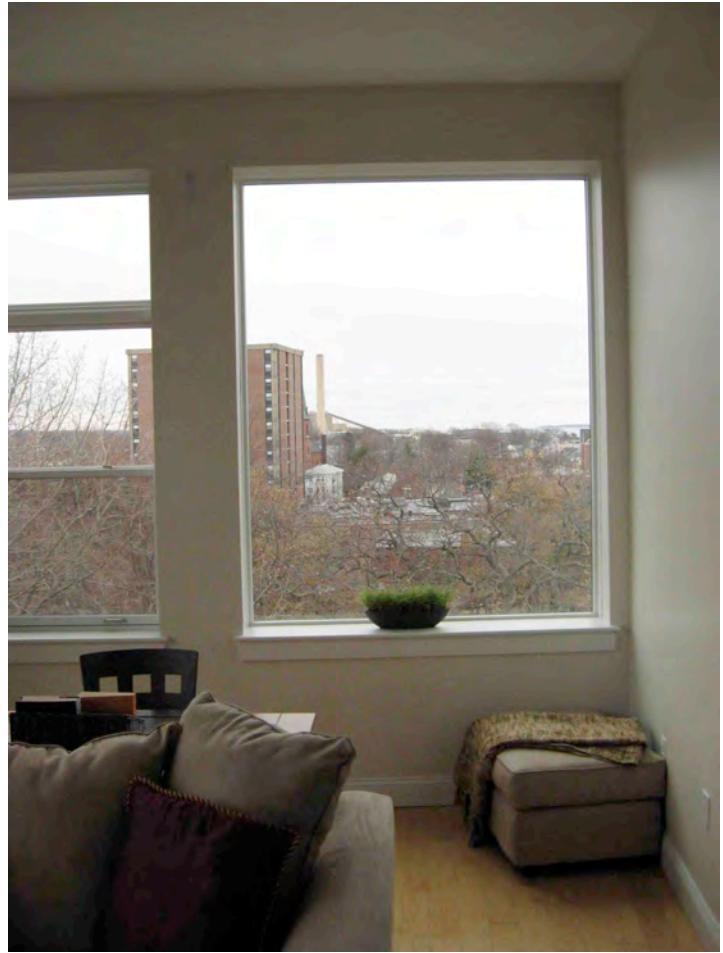
The windows in Residential Units are relatively large, with operable double-hung sashes being almost four feet in width and over two feet in height, and fixed units being over seven feet in width and almost seven feet in height (see Photograph #7). Many of the double-hung windows are set in multiple unit openings, with mulled connections between individual window frames.

Photograph #7 – Large Fixed Window Unit

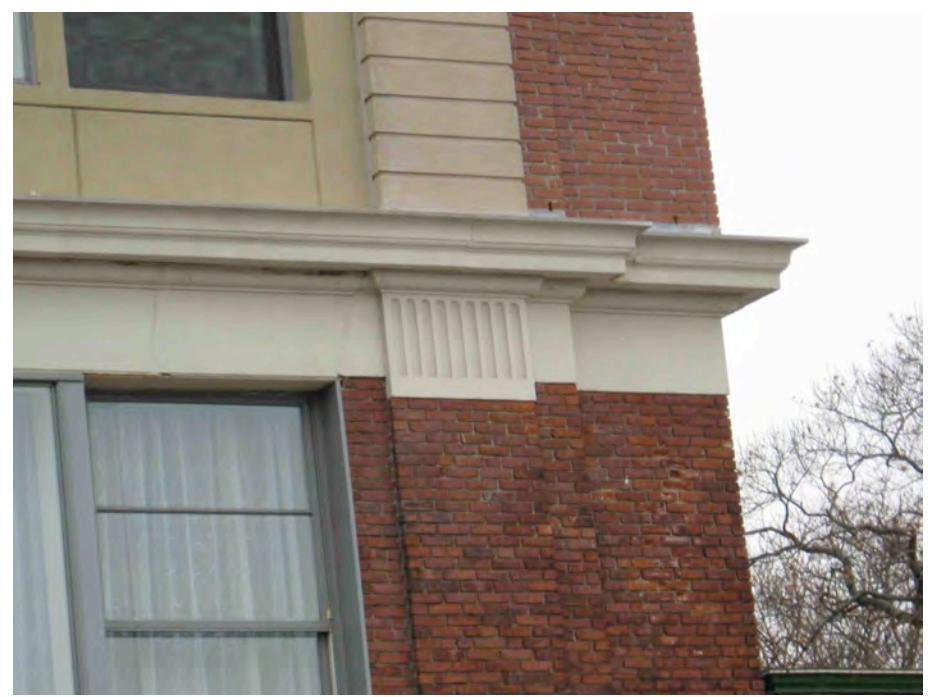
The lower five floors of the building include various decorative stone elements, including cut stone watertables and window opening keys on the original masonry walls, and cast stone vertical columns, balcony parapet caps and watertables on new masonry and EIFS wall sections (see Photograph #8). In addition, the Lafayette Street elevation of the North Building includes cut stone veneer on the first floor.

Photograph #8 – Original Cut Stone Element (Lower) And Cast Stone Column (Upper)

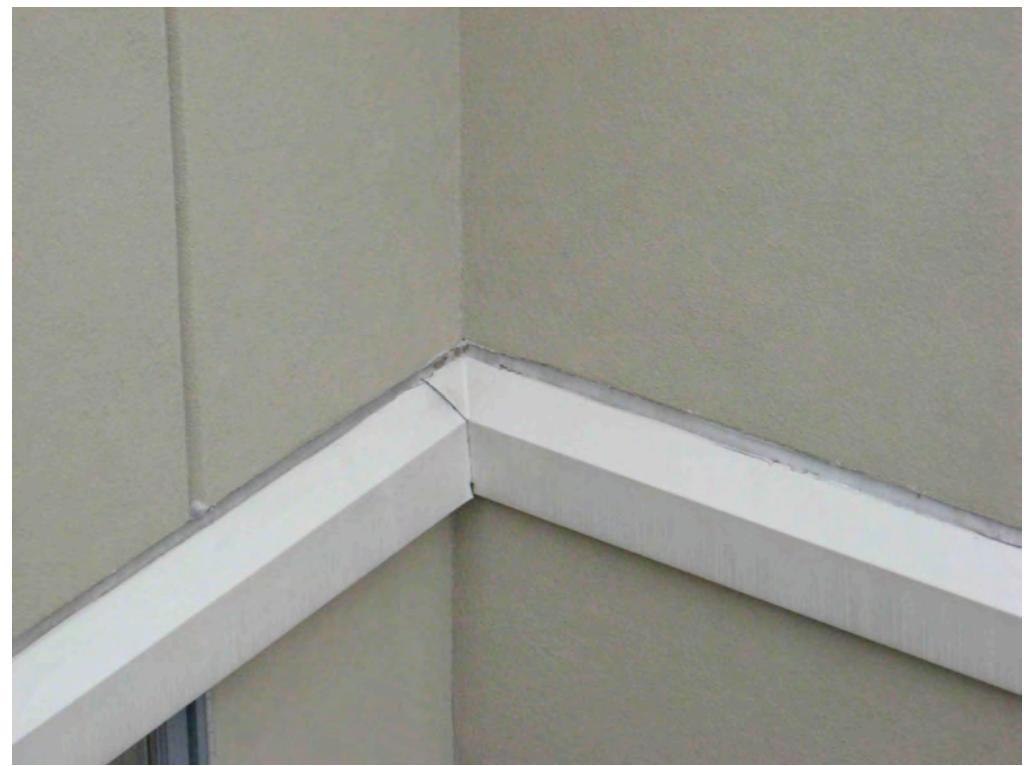
- Joints on window/door frame perimeters;
- Joints on EIFS panel perimeters;
- Joints on the aluminum clad belts in EIFS wall areas and metal caps on roof parapets (see Photograph #9);
- Joints between cast stone elements.

Photograph #9 – Sealant Joint On Metal Band In EIFS Wall Section

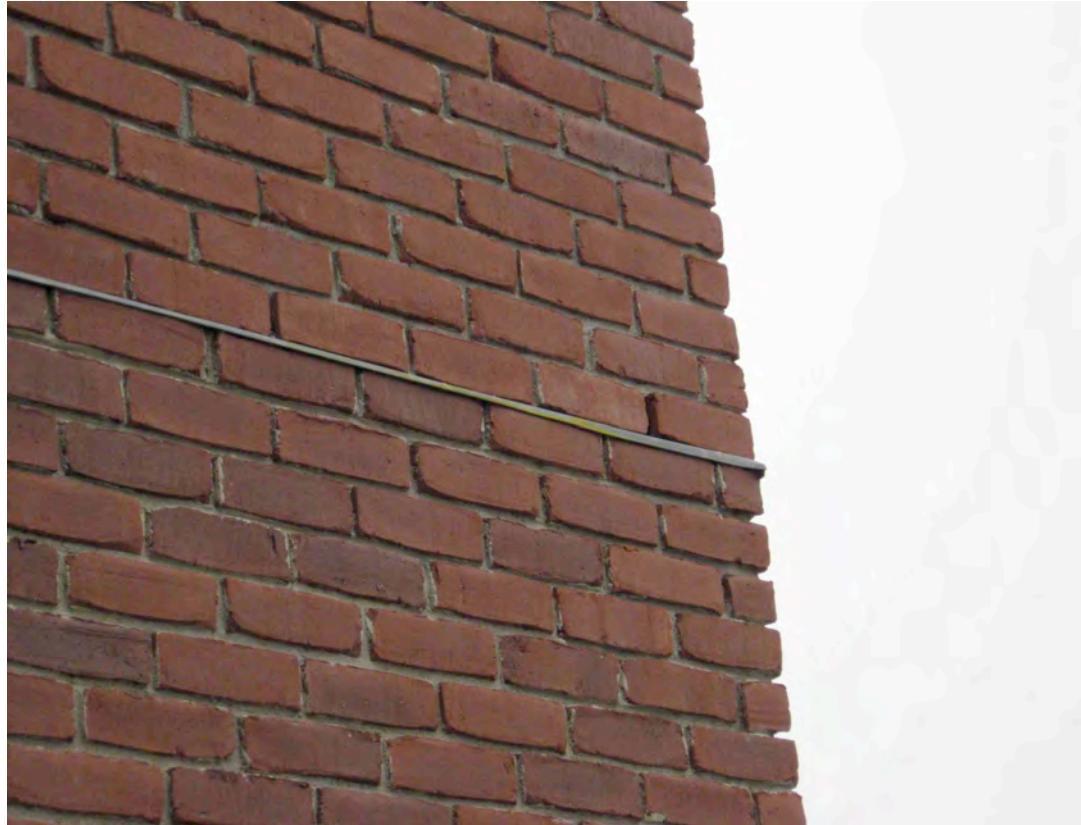
Inspection of the exterior wall areas revealed weep openings and what appeared to be lead coated copper (LCC) through wall flashings along the base of the veneer walls at the third floor level (see Photograph #11). Weep openings in these areas consist of open head joints between every third brick or approximately every 24". Weep openings set at similar spacings are also located above steel lintels spanning the window openings. Review of photographs from the conversion construction shows the back-up walls in the areas of new masonry veneer were provided with what appears to be an asphaltic waterproofing membrane in some areas, including at the levels of through wall flashings.

Photograph #11 – Metal Flashing And Weep Holes In Masonry Veneer Wall

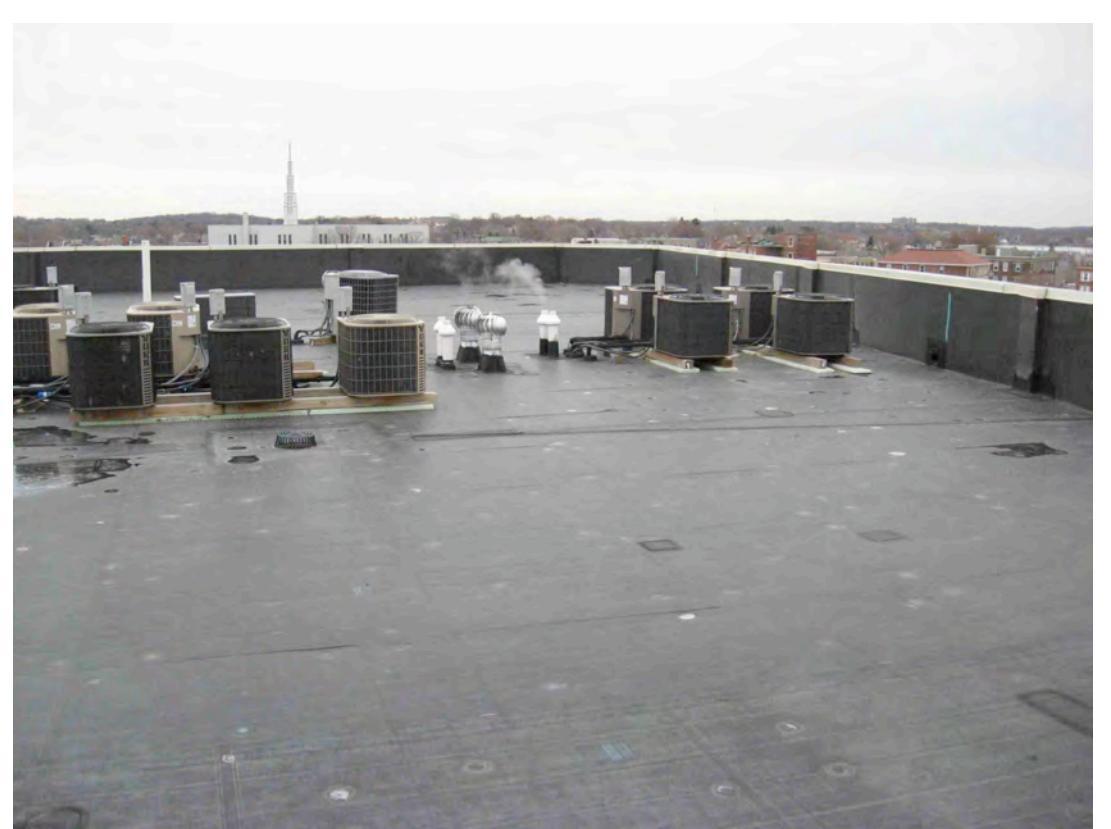
The main roof is bordered by solid parapet walls approximately four feet in height. Drainage from the roof surface is provided by internal drains located in tapered sumps at regular intervals. Tapered insulation crickets are located between the internal drains to direct accumulated water towards the drains (see Photograph #19). Overflow scuppers, set several inches above the membrane surface, are located in the parapet walls at various locations. Scupper openings of this type are intended to allow ponded water, which may accumulate on the roof surface due to clogged drains or other conditions, to flow to the exterior. Scuppers are flashed to the parapet membrane with uncured strip flashings. Lead coated copper scupper outlets are provided at the openings in the exterior parapet walls.

Photograph #19 – EPDM Membrane Roof With Crickets To Direct Water To Drains
